Caution

Engine wear can cause increased crankshaft endplay. This can result in damage to the Crankshaft Position Sensor.

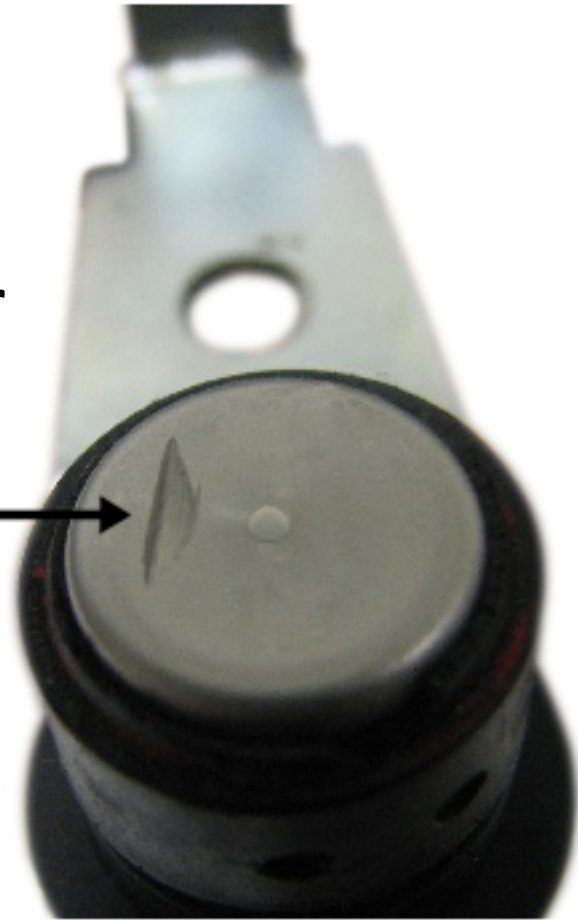
If you see score marks like this on your old sensor, you should install a spacer shim on the new sensor to prevent damage to the new sensor.
