TSBBWP9103

## 2004-1998 2.7L Chrysler Concorde/Dodge Intrepid Coolant Leak

**BWP-9103**

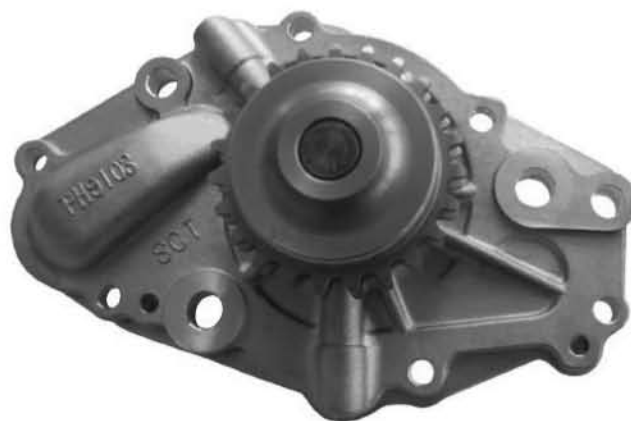
A severe coolant leak from the water pump's weep holes causes the coolant to destroy the pump's bearing, as well as leak into the engine's oiling system. Catastrophic engine failure can result.

This engine's water pump is buried beneath the timing cover since it is internally driven off the engine's timing chain. Since the front of the pump has direct contact with the engine's oiling system, the weep holes have been rerouted. Leaking coolant is channeled back through the pump and into the engine block. Therefore, if the water pump seal fails, the noticeable leaks will occur as coolant exits the left side of the engine block just below the thermostat housing and, if severe enough, from the rear of the engine block, towards the top.

Be aware of the potential leak points and do not ignore the signs of a leak. It also is recommended that the water pump be changed whenever servicing the timing chain and/or internal timing components.
