WIRING REQUIREMENTS FOR "CS" SERIES ALTERNATORS:

LOW OUTPUT

1987-1988 PONTIAC 6000 & GRAND PRIX 2.8L V6

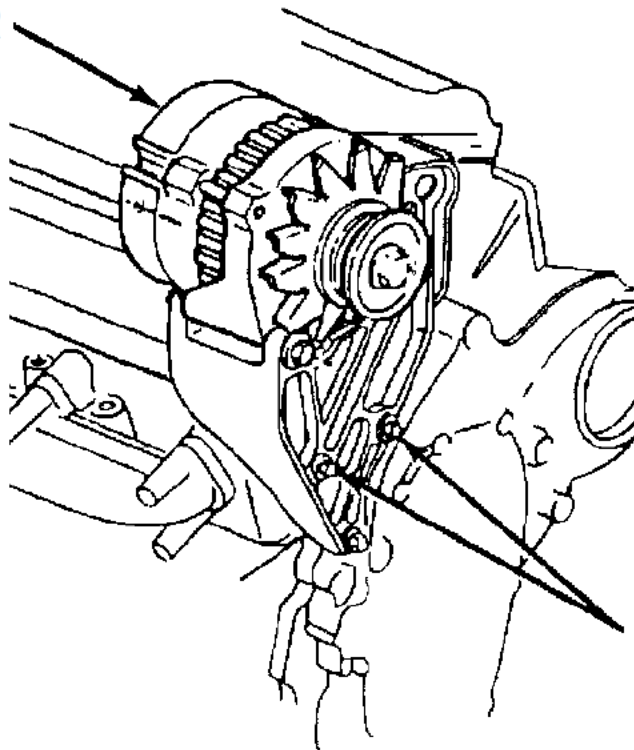
**BLACK STUDS
& NUTS**

LOW ALTERNATOR OUTPUT AND ALTERNATOR IS OPERATING CORRECTLY

THIS CONDITION IS CAUSED BY THE ALTERNATOR BRACKET HARDWARE BEING PHOSPHATE COATED (BLACK STUDS & NUTS) WHICH MAKES AN INSUFFICIENT GROUND PATH

1. LOCATE AFFECTED HARDWARE (SEE PICTURE)
2. REMOVE ONE (1) NUT AT A TIME (REPAIR ONE AT A TIME SO YOU DO NOT MOVE THE POSITION OF THE BRACKET)
3. CLEAN STUD WITH A WIRE BRUSH TO BARE METAL
4. REPLACE NUT WITH GM PART NUMBER #11502812 CADMIUM COATED NUT THAT IS MORE ELECTRICALLY CONDUCTIVE THAN THE ORIGINAL
