WIRING REQUIREMENTS FOR "CS" SERIES ALTERNATORS:

LOW OUTPUT

1987-1988 PONTIAC 6000 & GRAND PRIX 2.8L V6

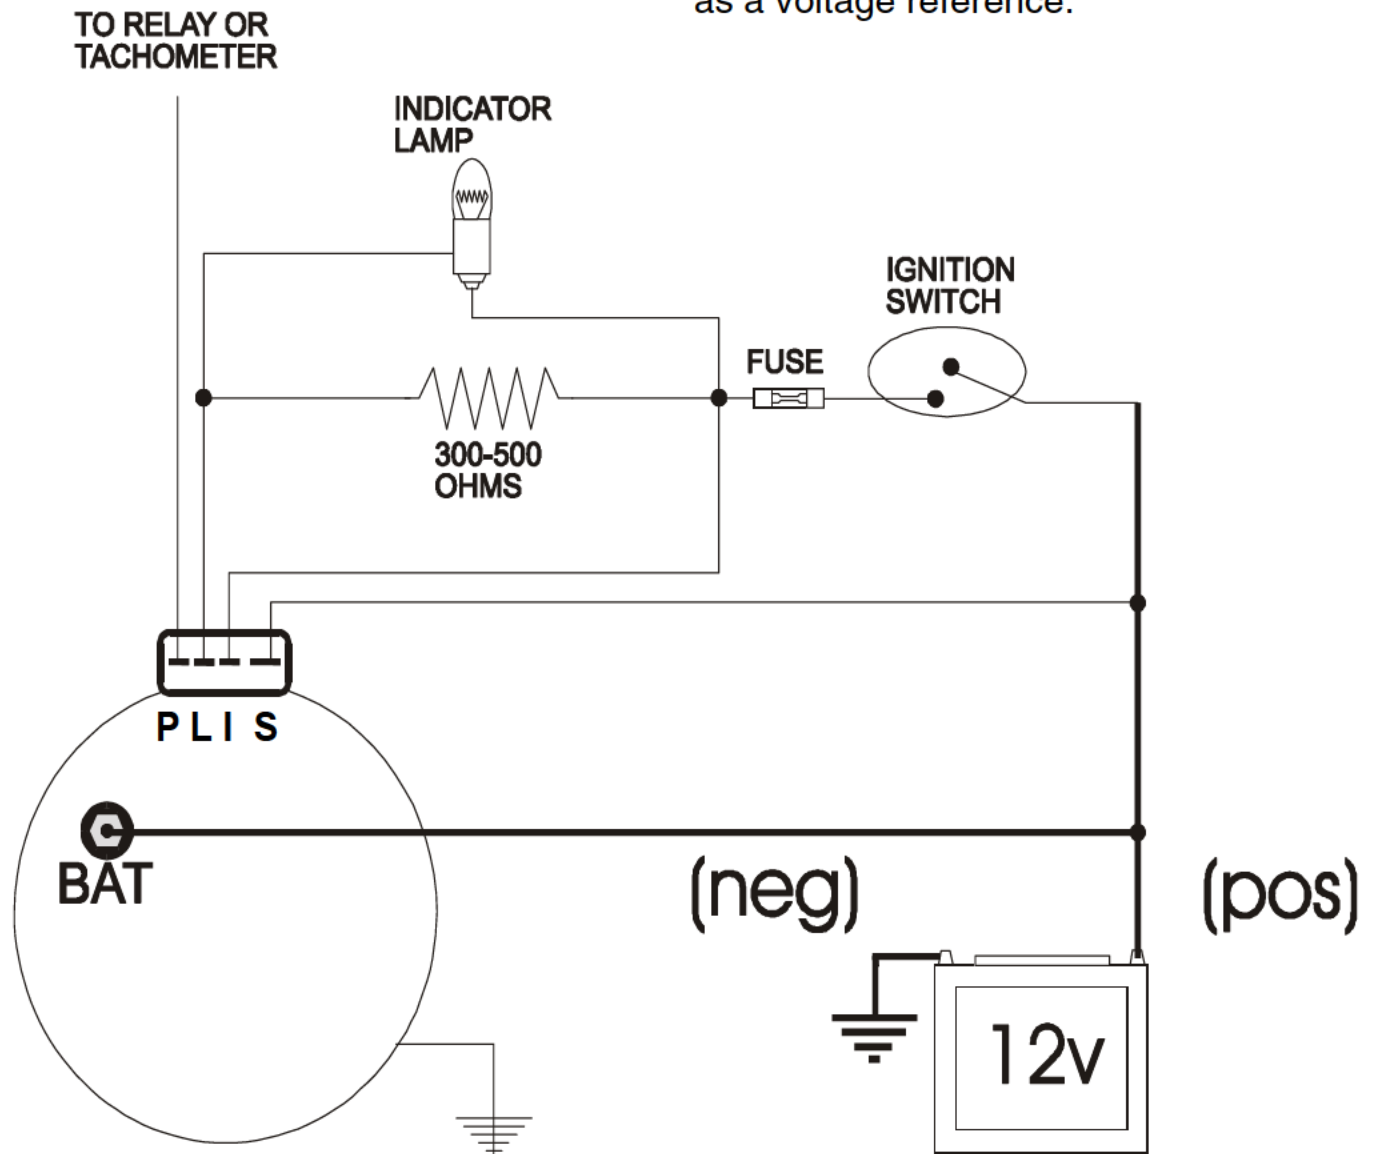
LOW ALTERNATOR OUTPUT AND ALTERNATOR IS OPERATING CORRECTLY

THIS CONDITION IS CAUSED BY THE ALTERNATOR BRACKET HARDWARE BEING PHOSPHATE COATED (BLACK STUDS & NUTS) WHICH MAKES AN INSUFFICIENT GROUND PATH

1. LOCATE AFFECTED HARDWARE (SEE PICTURE)
2. REMOVE ONE (1) NUT AT A TIME (REPAIR ONE AT A TIME SO YOU DO NOT MOVE THE POSITION OF THE BRACKET)
3. CLEAN STUD WITH A WIRE BRUSH TO BARE METAL
4. REPLACE NUT WITH GM PART NUMBER #11502812 CADMIUM COATED NUT THAT IS MORE ELECTRICALLY CONDUCTIVE THAN THE ORIGINAL
